Installation instructions

For set # 8.10107

07-13 Toyota Tundra

Power Steering Gear Bushings

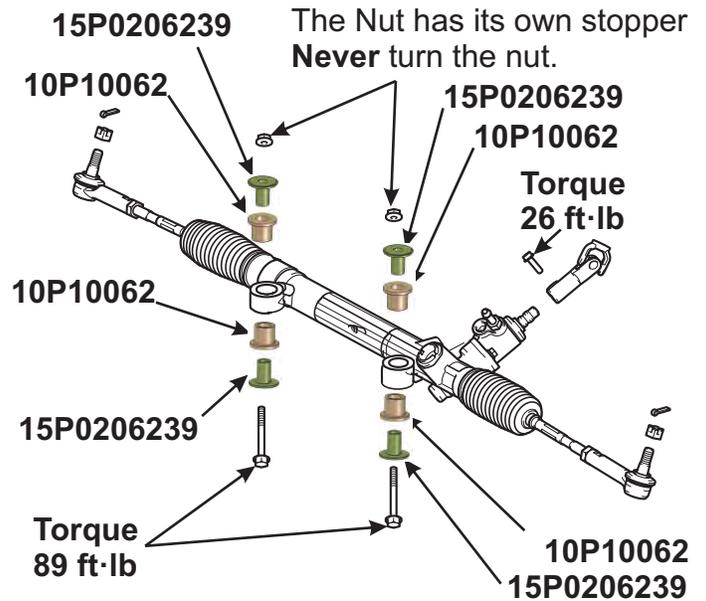
- Parts list: 8.10107**
- 4 - 10P10062 Power Steering Gear Bushing
 - 4 - 15P0206239 Inner Flanged Sleeve
 - 1 - 17P17633 Instruction Sheet

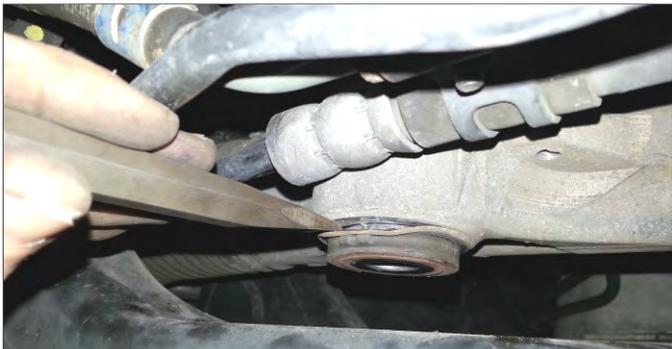
Passenger side: The rack will move toward the passenger side and forward just enough to remove the bushing. Use a Tie-Down strap to hold rack in place while removing bushing.

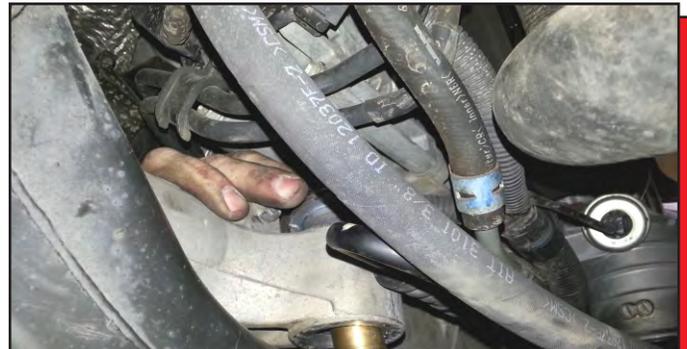
Driver side: The rack will move toward the passenger side and forward just enough to remove the bushing.
