FITTING INSTRUCTIONS

Suits: Commodore VR-VE

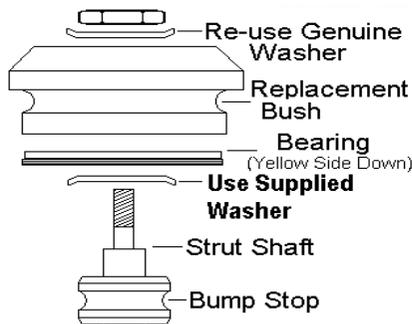
5. With bump stop in position fit **supplied** cup washer, replacement **4018A** bush (with bearing in place, yellow side down), **original upper** cup washer in the correct position as per diagram below.

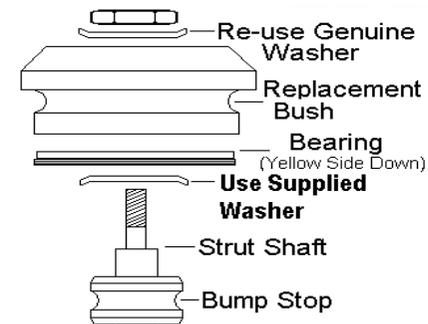
5. With bump stop in position fit **supplied** cup washer, replacement **4018A** bush (with bearing in place, yellow side down), **original upper** cup washer in the correct position as per diagram below.
