Installation instructions

For set # 8.3139
 10-20 Lexus GX 460
 10-20 Toyota 4Runner
 W/Dynamic Suspension

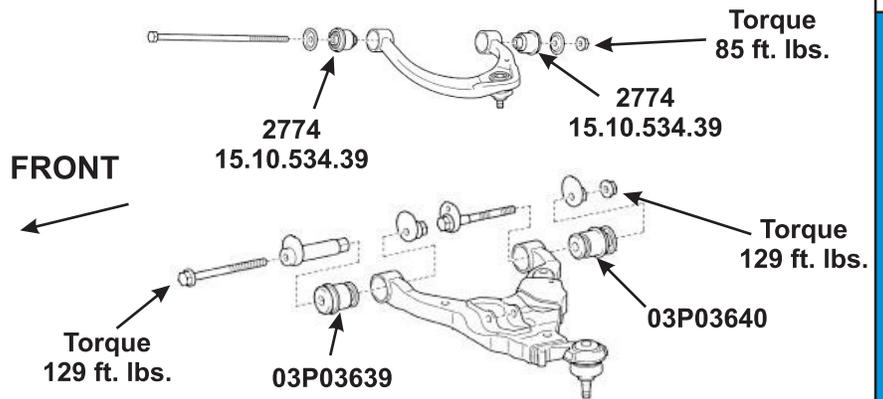
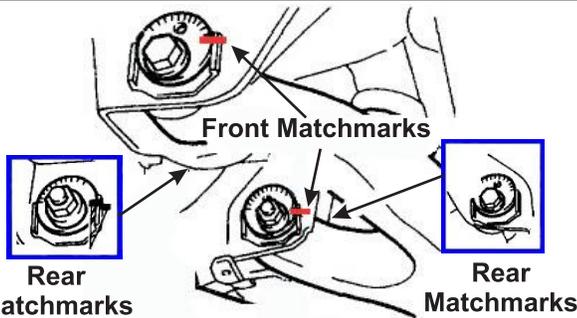
Be sure to place matchmarks on the front and rear adjusting cams before you start. You will need to use these matchmarks to reinstall the lower control arms back in the same position after the new polyurethane bushings are installed. Torque to 129 ft. lbs. Then have the vehicle's alignment checked by a certified technician. The alignment must be within factory specifications.

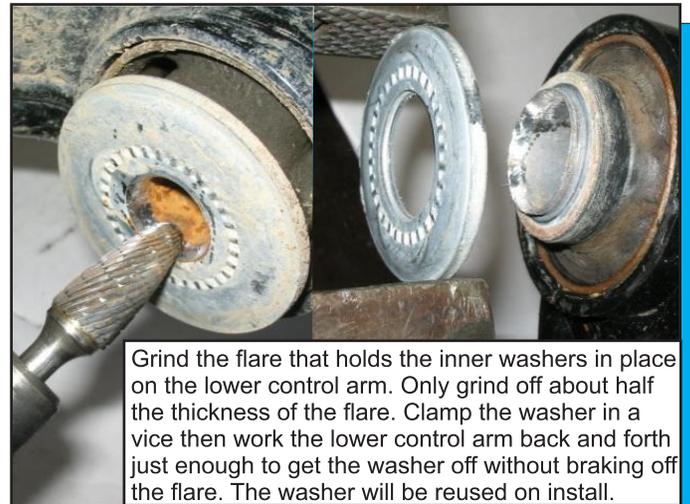
Grind the flare that holds the inner washers in place on the lower control arm. Only grind off about half the thickness of the flare. Clamp the washer in a vice then work the lower control arm back and forth just enough to get the washer off without braking off the flare. The washer will be reused on install.

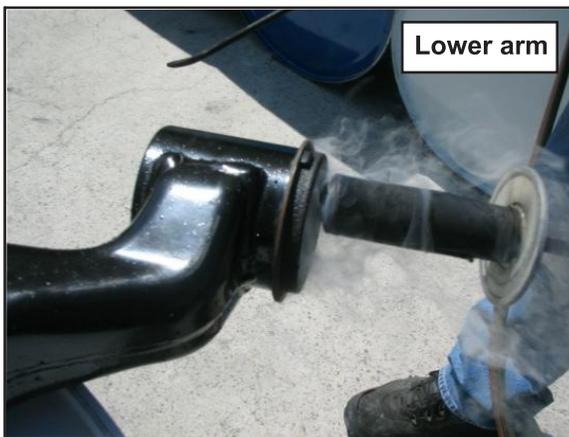
Do not remove the factory metal shells from the lower control arms, they must be reused. The inner metal sleeves and washers on the lower control arm must be reused. To remove the old rubber from the factory shells and inner sleeves, apply light heat evenly around the outside of the control arm outer metal shell, just enough to brake the bond with the rubber. Do the same on the inside of the sleeves on the lower control arms. When you see light smoke coming from the sides of the bushing the bond should be broken. At no time should there be any flames coming from the rubber, if there are any flames, you need to back off with the heat. Just push the old rubber and inner metal sleeve out. Let the outer metal shells and sleeves cool off before cleaning. Use a wire brush to remove any remaining old rubber. File off any sharp edges that will contact the new polyurethane bushings.

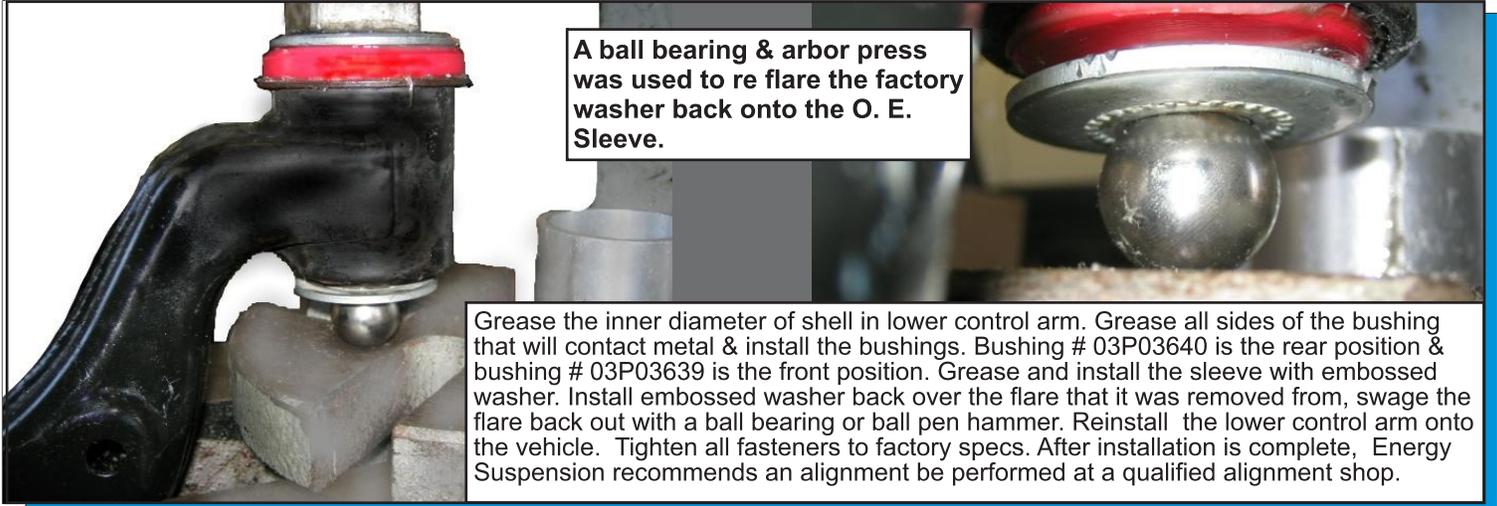
A ball bearing & arbor press was used to re flare the factory washer back onto the O. E. Sleeve.

Grease the inner diameter of shell in lower control arm. Grease all sides of the bushing that will contact metal & install the bushings. Bushing # 03P03640 is the rear position & bushing # 03P03639 is the front position. Grease and install the sleeve with embossed washer. Install embossed washer back over the flare that it was removed from, swage the flare back out with a ball bearing or ball pen hammer. Reinstall the lower control arm onto the vehicle. Tighten all fasteners to factory specs. After installation is complete, Energy Suspension recommends an alignment be performed at a qualified alignment shop.

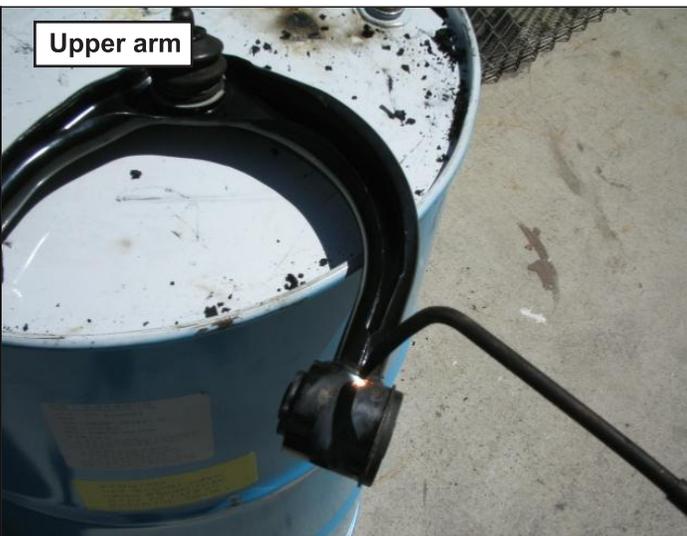
Upper arm

Do not remove the factory metal shells from the upper control arms, they must be reused. New inner metal sleeves are supplied for the upper control arms. To remove the old rubber from the factory shells and inner sleeves, apply light heat evenly around the outside of the control arm, just enough to brake the bond with the rubber. When you see light smoke coming from the sides of the bushing the bond should be broken. At no time should there be any flames coming from the rubber. If there are any flames, you need to back off with the heat. After the bond is broken, you will push the old rubber and inner metal sleeve out. Let the outer metal shells and sleeves cool off before cleaning.

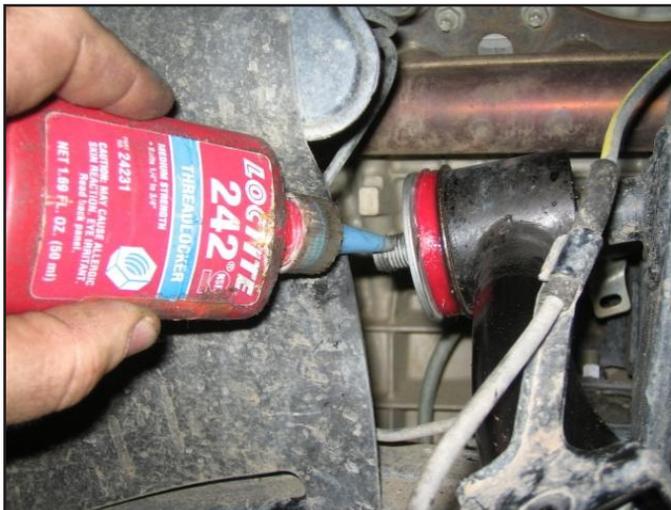
Use a wire brush to remove any remaining old rubber. File off any sharp edges that will contact the new polyurethane bushings. Apply grease to all metal parts that contact the polyurethane bushings. Apply thread locking compound to upper control arm through bolt then torque to 85 ft. lbs.
